FACILITY AUDIT

PALMER PUBLIC SCHOOLS

PALMER, NE

AUGUST 29th, 2023

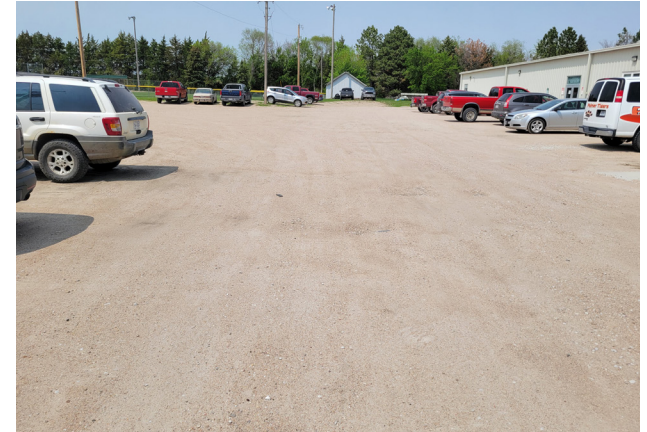
The parking lots are gravel and do not have a clearly defined parking layout or direction. Gravel also poses ongoing maintenance issues with snow removal, erosion, and loss of gravel. An uneven, muddy or loose gravel poses a safety concern for slips and falls. A paved parking lot would have painted parking stalls and can be spaced more efficiently together and allow more parking availability. Along with safety and maintenance, a paved parking lot would reduce the amount of mud, dirt and gravel that is tracked into the building.

Fig. 3.4.5: Parking Lot, 2023.

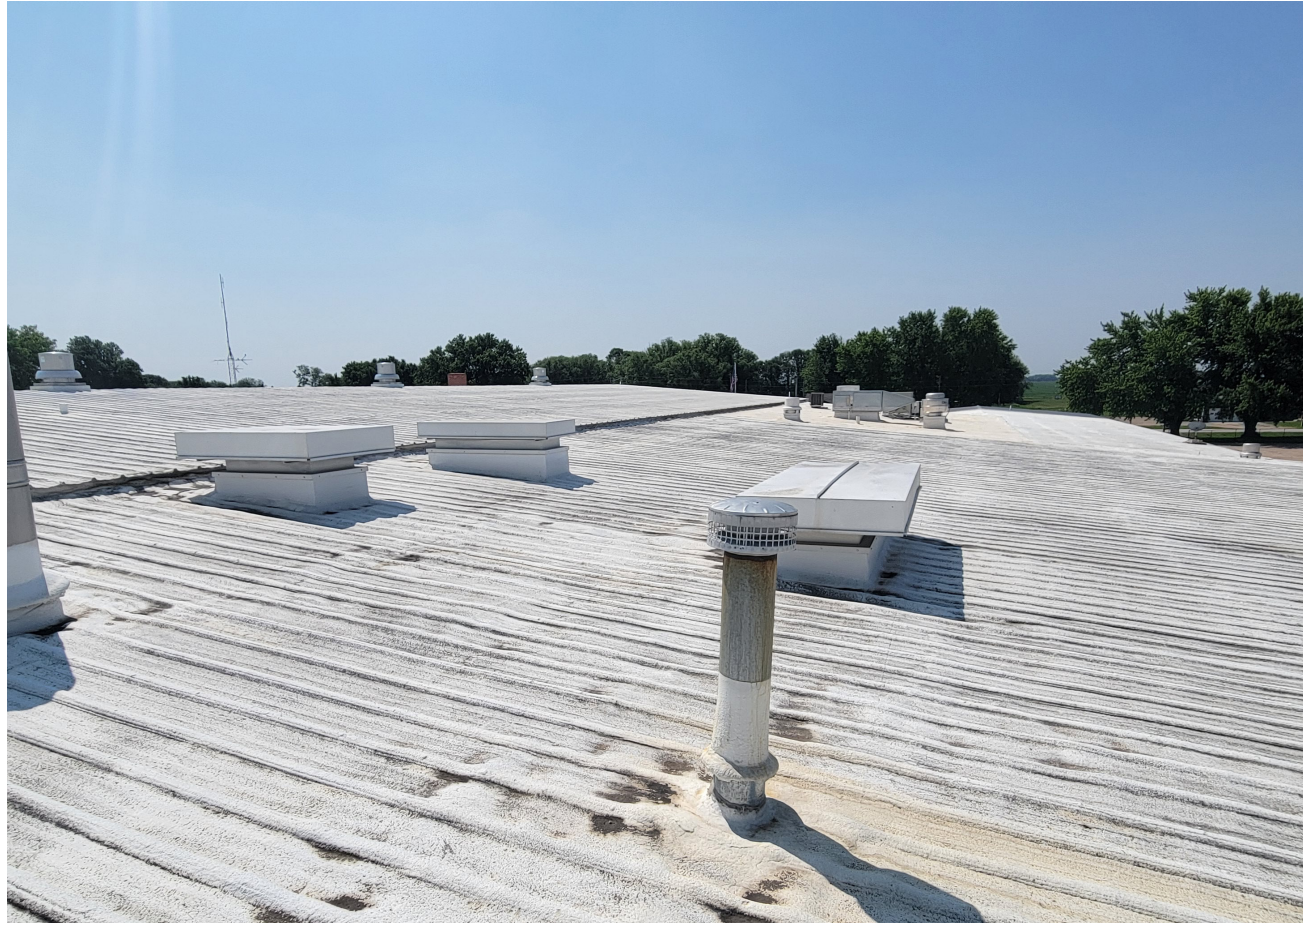
Roofs are consistent with surface fastener metal panels typical with pre-engineered metal buildings. The roofs have been spray coated over the entire facility with a urethane foam coating system. While adding additional layers of coatings solves an immediate need, it isn't a long term 30-40 year solution. Spray coatings are susceptible to impact damage and it is difficult to identify where leaks are occurring. Other than adding additional layers of coating, repairs are difficult to perform. Repairs are weather dependent and have to be performed by a company with specialized equipment.

Fig. 3.4.33: Metal Roof, 2023.

A typical low-slope roofing material used in modern school construction practices consists of a fully adhered TPO or EPDM membrane roof. A roof system such as this can have warranty periods of 25-30+ years and lifespans of 40+ years. A recommended re-roof plan could include replacement with either of these single ply roofing options. Roof insulation is typically added during a roof replacement which reduces utility bills and thermal comfort. Code minimum is R-30 when insulation is entirely above the roof deck.

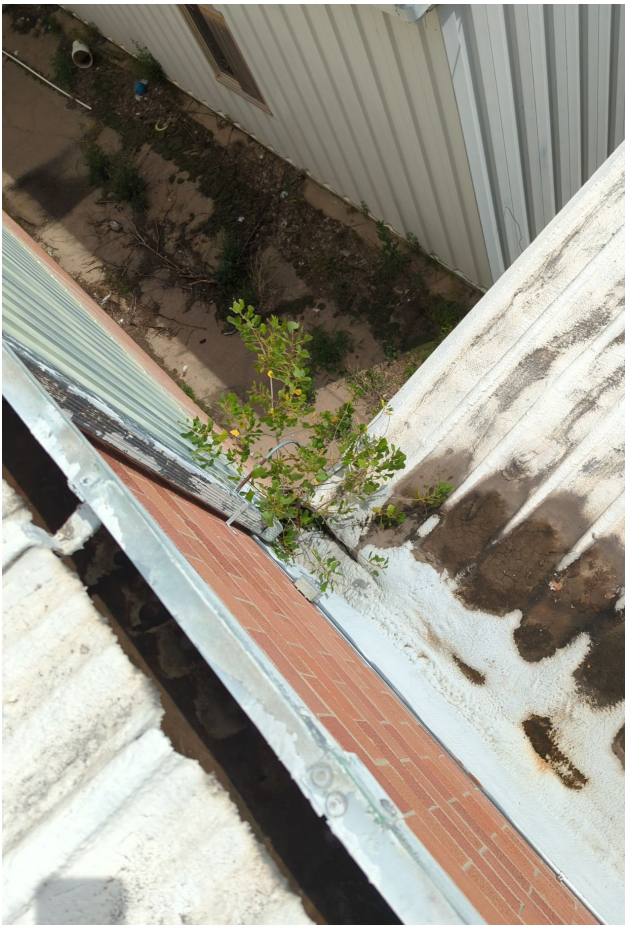
In order to provide proper storm water management and prevent water infiltration into the building, cleaning gutters and downspouts should be preformed. With vegetation growing in gutters, it is likely they haven't been cleaned in a while.

Fig. 3.4.39: Roof Tree , 2023.

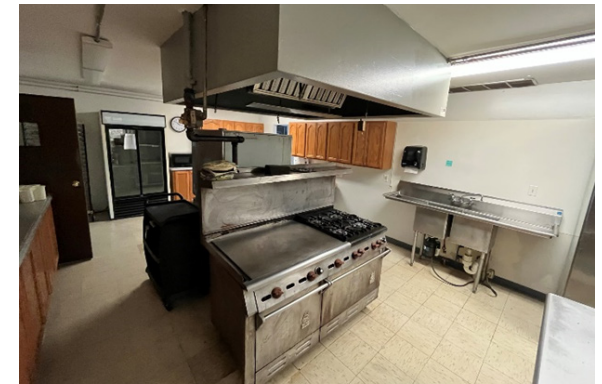
The kitchen plumbing fixtures consists of a stainless steel 3-bowl sink, 2-bowl prep sink with disposer, dishwasher for glass ware only and a vitreous china hand sink. The kitchen plumbing fixtures appear to be in good shape. The faucets should be replaced. The 3-bowl and 2-bowl sinks would be more functional if a spray rinse would be added to the sinks. It does not appear that a grease trap has been installed.

Fig. 3.5.2: 2-Bowl Sink, 2023.

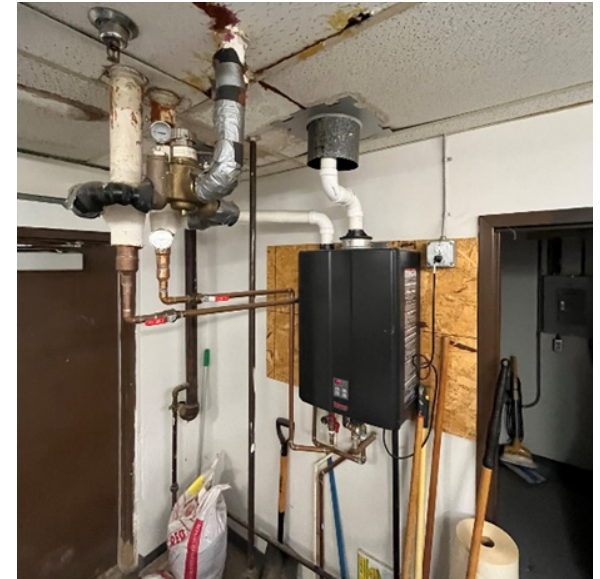
The building contains (1) instantaneous gas fired domestic hot water heater located in the mechanical room. The water heater appears to be newer and in decent condition. The water heater input capacity is 199,000 btu/h. There is a mixing valve allowing for 140°F water to be delivered to the kitchen and 110°F delivered to the rest of the building plumbing fixtures. There is not a domestic hot water recirculation system in this building.

Fig. 3.5.4: Domestic Hot Water Heater, 2023.

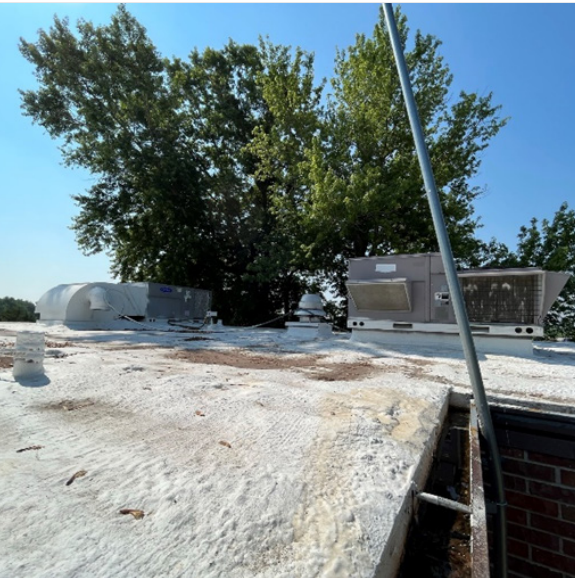
The lunchroom is served by a dedicated single zone Carrier rooftop unit. This unit appears to be old and nearing its life expectancy. It is recommended that this unit be scheduled for replacement in the near future.

Fig. 3.5.7: Lunch Room & Kitchen Rooftop Units, 2023.

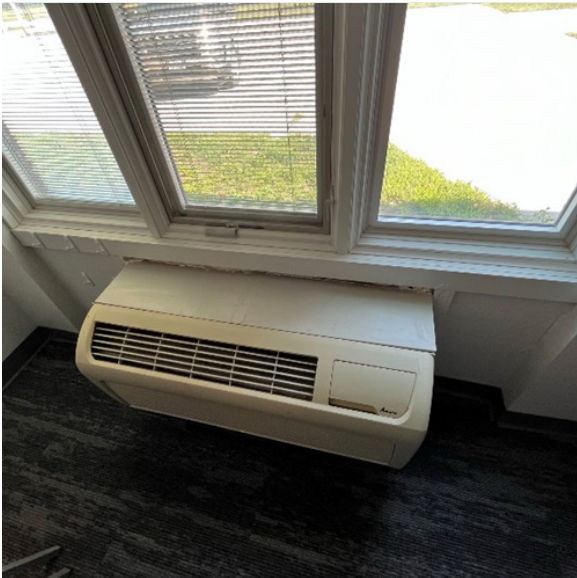
The west wing contains classrooms that are served by “thru the wall” package terminal air conditioners (PTAC). The PTACs appear to be old and near the end of their life expectancy. Also, PTACs do not bring in the required amounts of fresh air for current classroom ventilation code requirements. The west wing also contains a newer rooftop unit that serves the corridor and provides some fresh air into the classrooms. This unit appears to be in decent condition.

Fig. 3.5.8: Packaged Terminal Air Conditioner (PTAC), 2023.

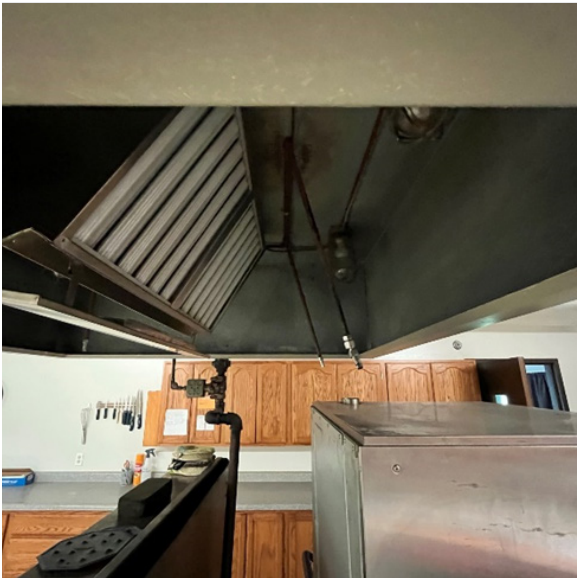
Fig. 3.5.9: Kitchen Hood Doesn't Extend Over Combi. Oven, 2023.

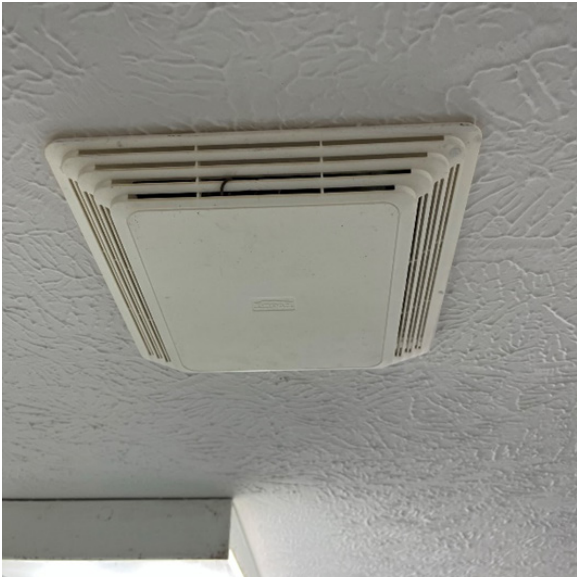
The ceiling mounted exhaust fans are not operable. These exhaust fans should be replaced with new.

Fig. 3.5.11: Typical Ceiling Mounted Exhaust Fan, 2023.
