FACILITY AUDIT

PALMER PUBLIC SCHOOLS

PALMER, NE

AUGUST 29th, 2023

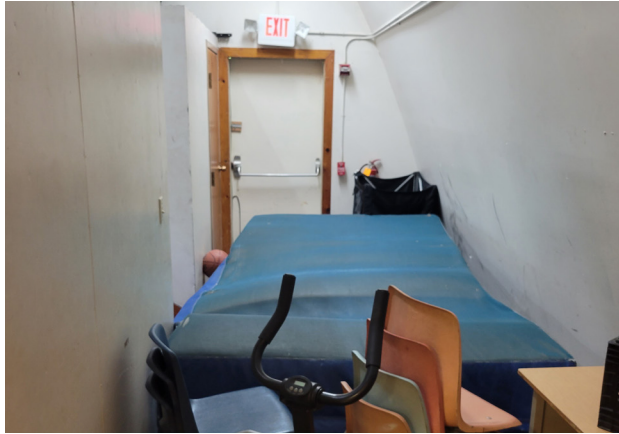
The rear exit doors need to have the egress path remain clear. The stored items blocking the doors need to be removed

Fig. 3.2.2: Interior Exit, 2023.

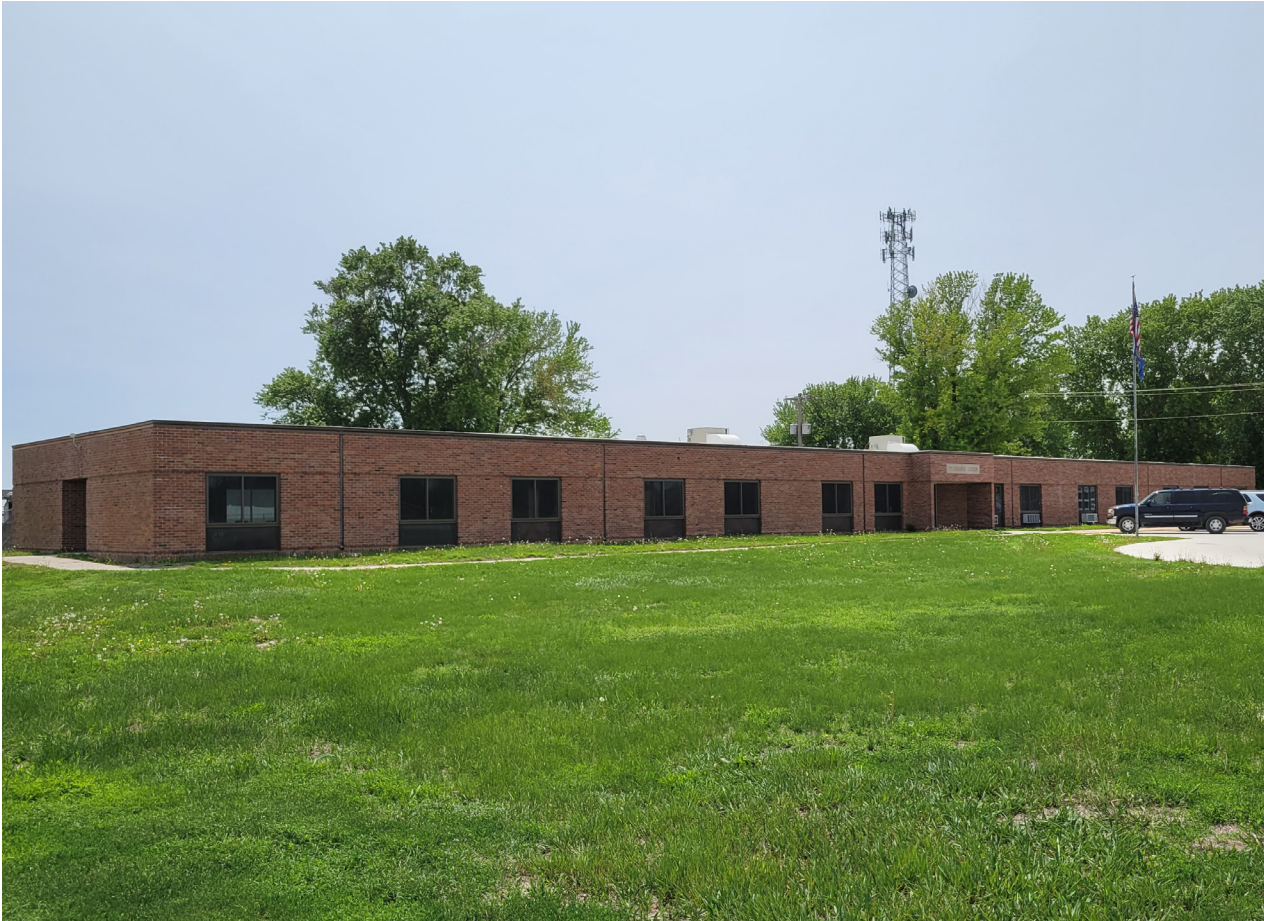
The exterior envelope is in good condition with brick veneer and recently replaced windows. The gutters and downspouts are showing signs of distress and could be considered for replacement when the roof is replaced next. The roof has been spray coated to gain some years on the overall lifespan. While adding additional layers of coatings solves an immediate need, it isn't a long term 30-40 year solution. Roof replacement could be budgeted for within the next 10 years.

Fig. 3.3.1: Exterior Facade, 2023.

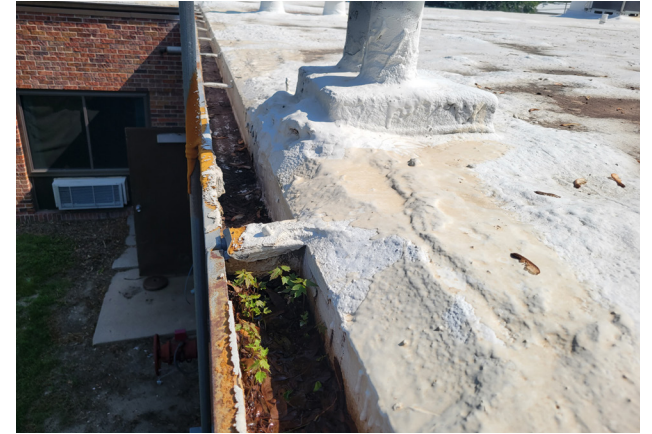
Fig. 3.3.2: Roof Drain 2023.

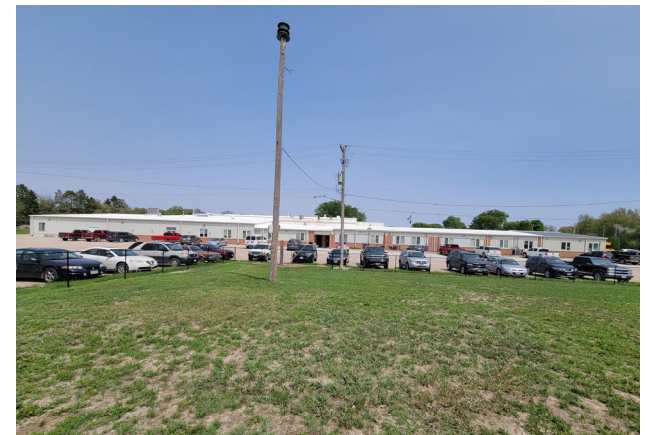
Fig. 3.4.6: Exterior Site, 2023.

The flat nature of the site causes drainage, stormwater management and ice issues. Ponding and mud holes are consistent issues that the maintenance staff contends with. Some improvements have been made with directing downspouts below grade and daylighting at a swale to the north. Paving the parking lot could

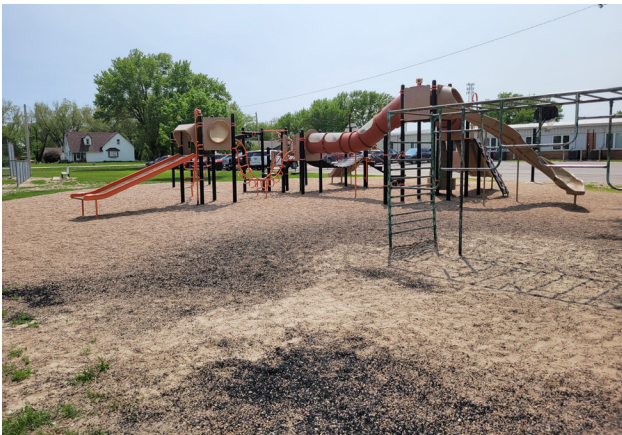
Fig. 3.4.11: Playground, 2023.

The Elementary playground has undergone recent improvements with new playground equipment and asphalt play surface. Both are in good condition. Some components could be added to make the equipment more inclusive and ADA accessible.

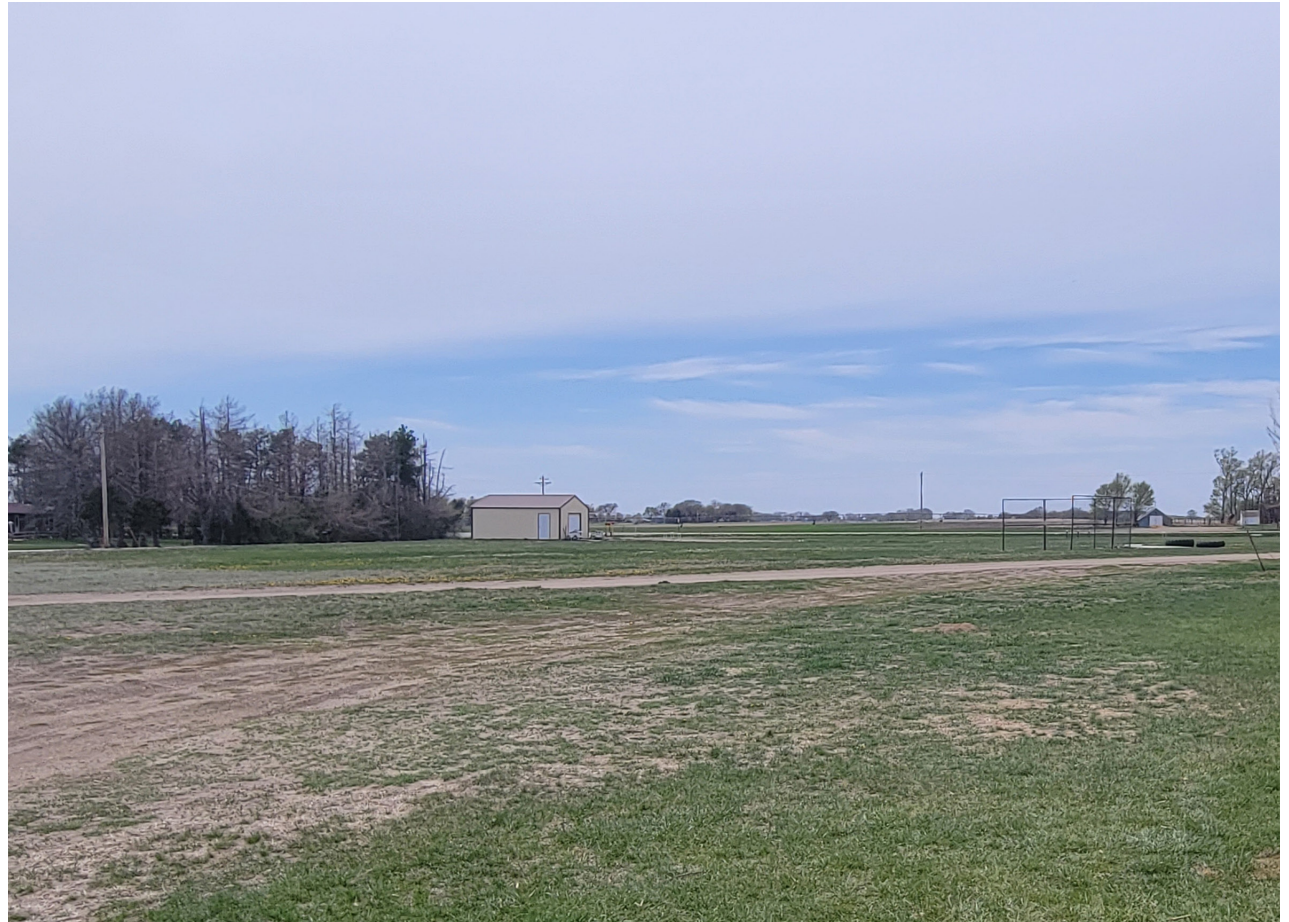
Fig. 3.4.14: Track, 2023.

Palmer does not have a track which is lacking compared to the peer districts. Without a dedicated hard surface track and field events, it is difficult to properly have track practice and host track meets. It has been discussed with community groups about a desire for a walking path around the perimeter of the school property. If a track is constructed, there could be a cost share where walking path funds are directed to the track costs. That would allow Palmer community members to utilize the track for walking.

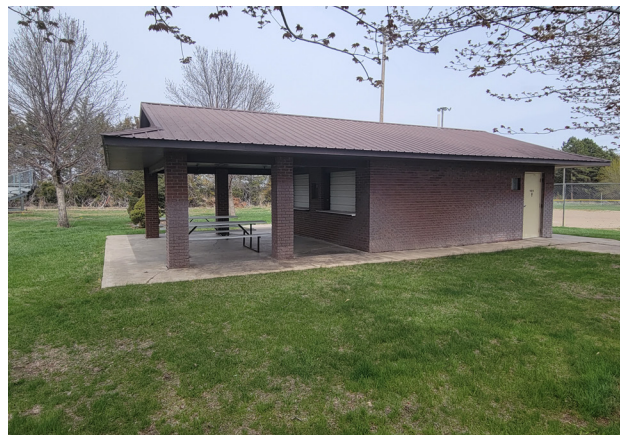
Fig. 3.4.15: Concession and Restrooms, 2023.

Accessory structures that support the athletic fields include a brick restroom/concessions building between the baseball and softball fields, which is in good condition. This is utilized for football games. There is a pressbox structure at center field and is in good condition.

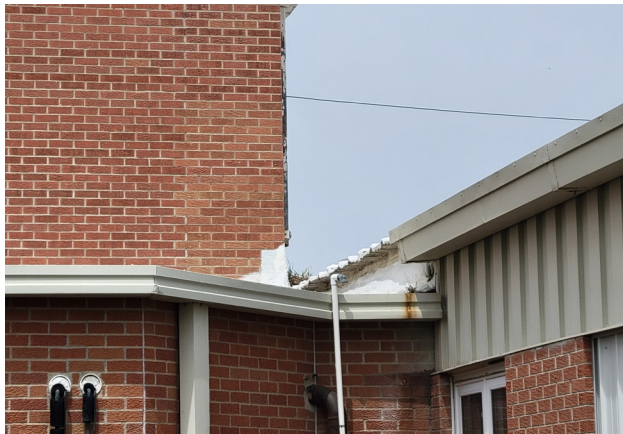
Fig. 3.4.29: Roof Spray Coating, 2023.

Roofs are consistent with surface fastener metal panels typical with pre-engineered metal buildings. The roofs have been spray coated over the entire facility with a urethane foam coating system. While adding additional layers of coatings solves an immediate need, it isn't a long term 30-40 year solution. Spray coatings are susceptible to impact damage and it is difficult to identify where leaks are occurring. Other than adding additional layers of coating, repairs are difficult to perform. Repairs are weather dependent and have to be performed by a company with specialized equipment.

A typical low-slope roofing material used in modern school construction practices consists of a fully adhered TPO or EPDM membrane roof. A roof system such as this can have warranty periods of 25-30+ years and lifespans of 40+ years. A recommended re-roof plan could include replacement with either of these single ply roofing options. Roof insulation is typically added during a roof replacement which reduces utility bills and thermal comfort. Code minimum is R-30 when insulation is entirely above the roof deck.

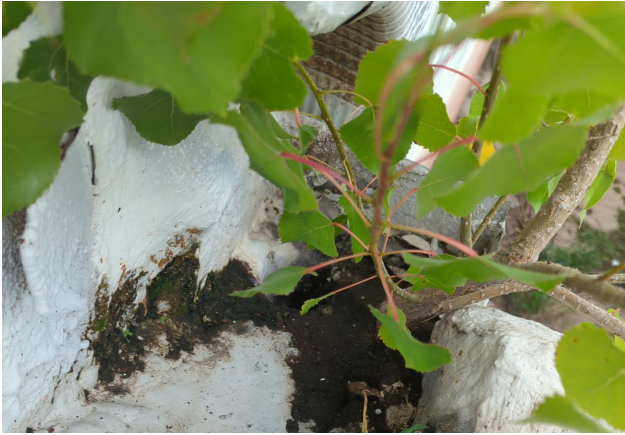
Fig. 3.4.36: Roof Tree, 2023.

In order to provide proper storm water management and prevent water infiltration into the building, cleaning gutters and downspouts should be preformed. With vegetation growing in gutters, it is likely they haven't been cleaned in a while.

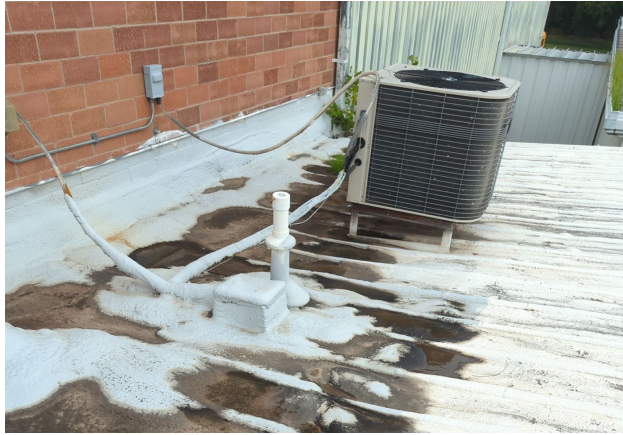
Fig. 3.4.37: Water build up, 2023.

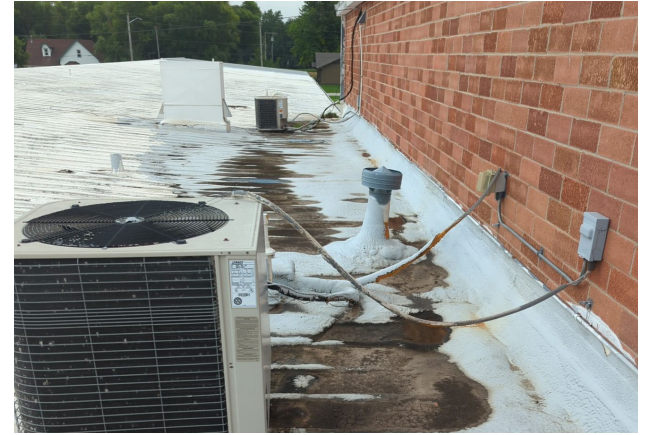
Fig. 3.4.38: Water build up, 2023.

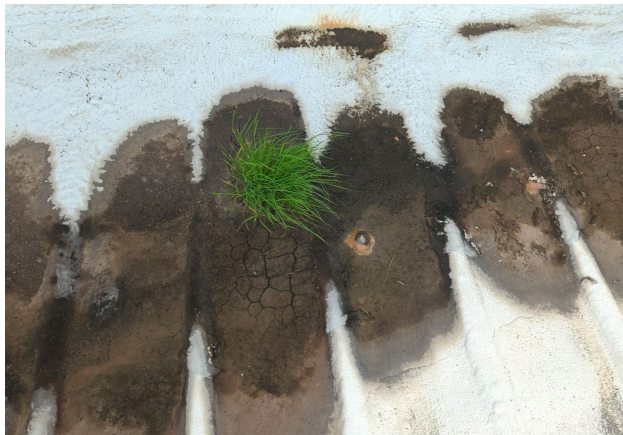
Fig. 3.4.40: Water build up, 2023.

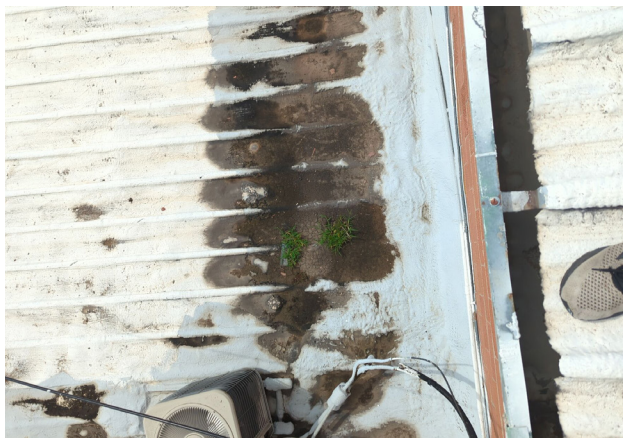
Fig. 3.4.42: Water build up, 2023.

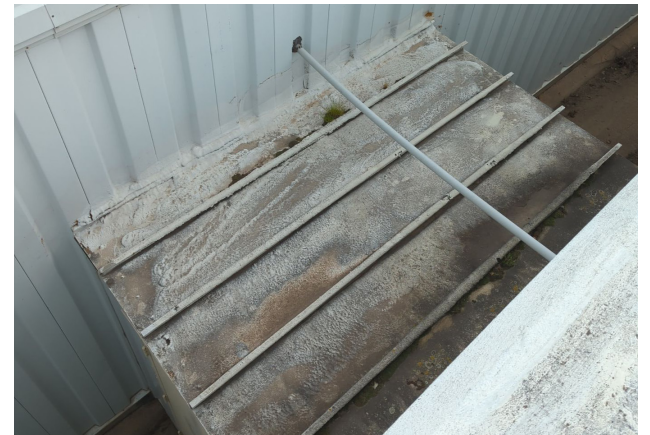
Fig. 3.4.41: Metal Roof, 2023.

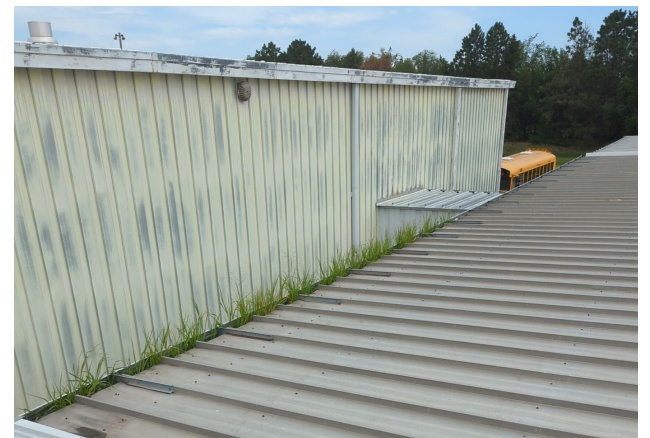
Fig. 3.4.43: Metal Roof, 2023.

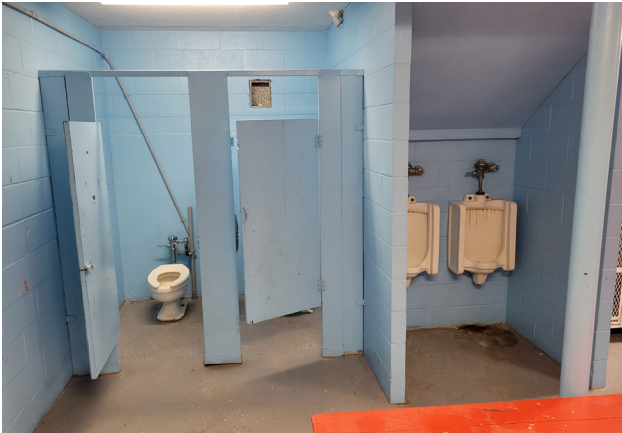
The High School locker rooms appear to meet ADA. The finishes are dated and showing age with general wear. Locker rooms in current school design are incorporating more privacy in the spaces with individual shower stalls and changing areas. The current Junior High locker rooms under the stage in the original 1960s building are not accessible, the finishes and fixtures are in poor condition, and the stairs down to the space do not meet current codes. The stage has similar concerns with ADA access and current stair dimensions. The locker rooms and stage would need extensive modifications to make them finished and accessible spaces.

Fig. 3.4.69: Lower Level Locker Room, 2023.

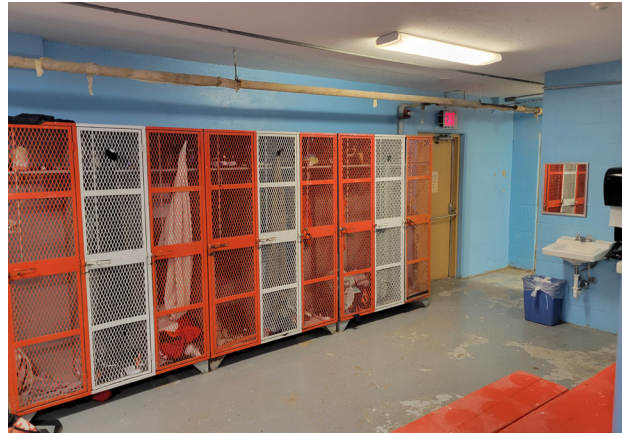
Fig. 3.4.70: Lower Level Locker Room, 2023.

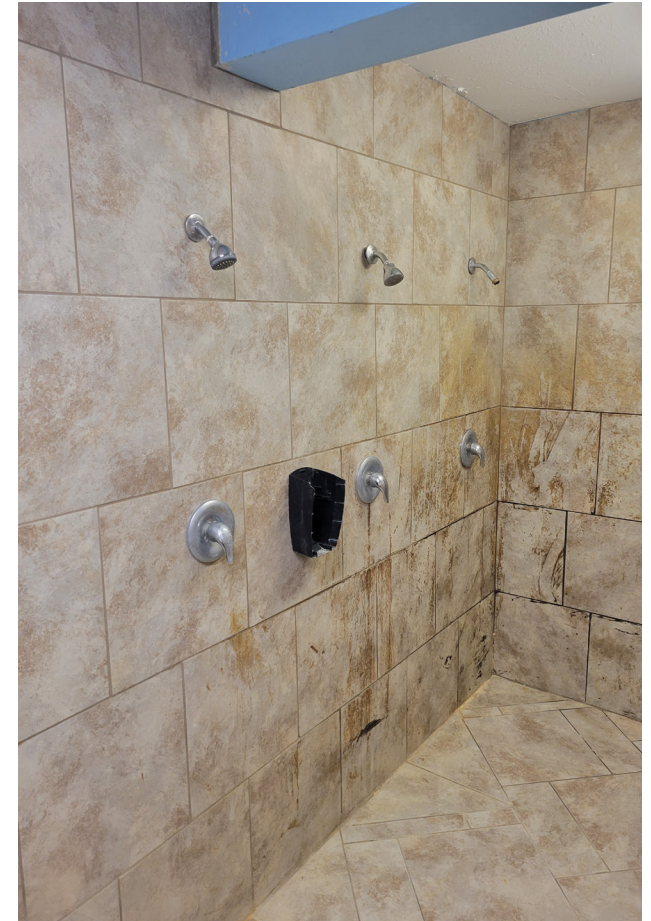
Fig. 3.4.73: Lower Level Showers, 2023.

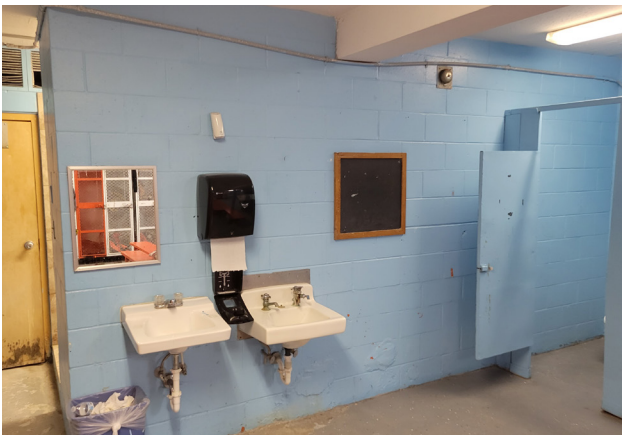
Fig. 3.4.71: Lower Level Locker Room, 2023.

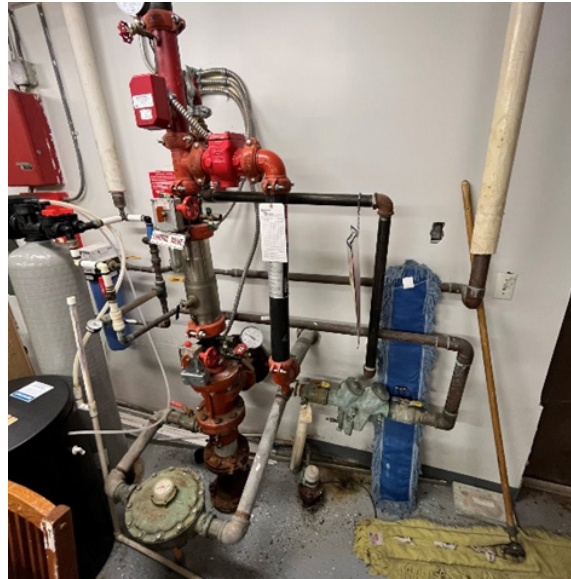
Fig. 3.5.3: Combination Fire/Water Service Entrance, 2023.

Prior to installing a fire sprinkler system into a building, a flow test shall be performed to determine available water pressure and flowrate available from the City. The Owner should be aware that along with the cost of a new fire entrance, other items of cost may be required if the City pressure and flowrates are not adequate; such as a fire pump if pressure is to low, backup generator if the electrical grid is not determined reliable, and possibly a large fire tank if the flow rate is inadequate.

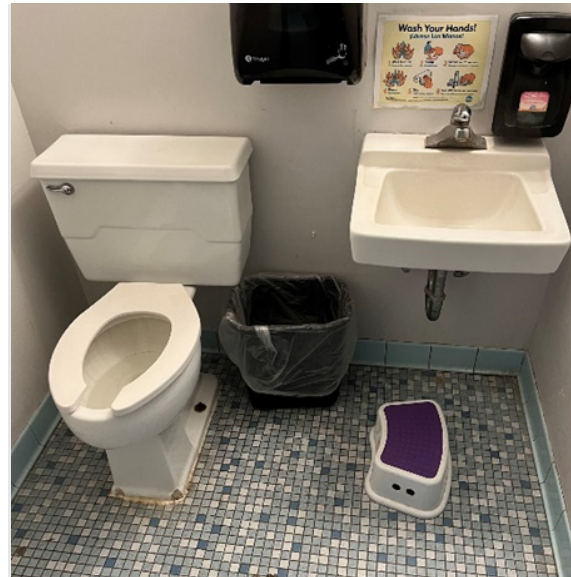
The restroom plumbing fixtures are old and in need of replacement.

Fig. 3.5.5: Typical Restroom Plumbing Fixture, 2023.

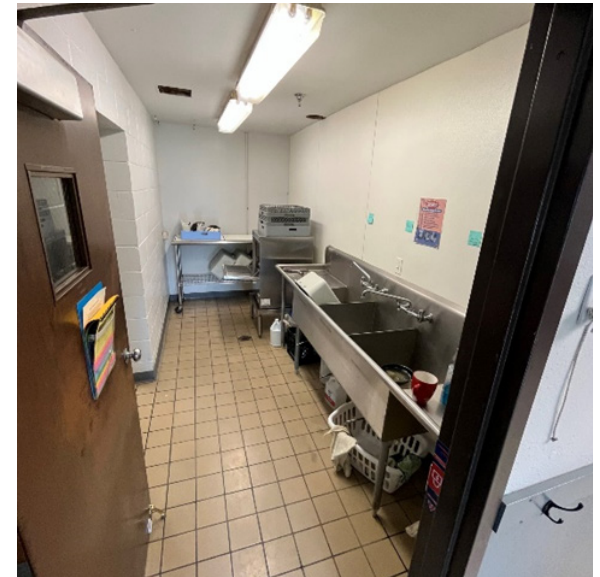
Fig. 3.5.6: 3-Bowl Sink, 2023.

The kitchen consists of multiple stainless steel plumbing fixtures (3-bowl sink with disposer and pre-rinse, prep sink, dishwasher with electric booster heater, and hand sink). The fixtures appear to be in decent working condition. It does not appear that a grease trap has been installed.

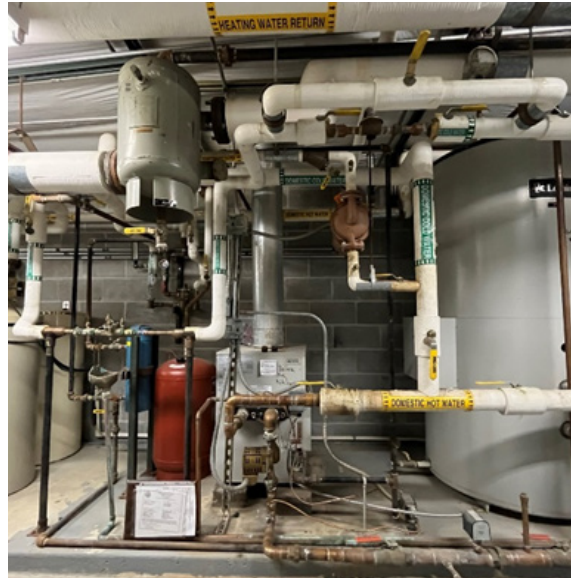
Fig. 3.5.12: 1994 Addition: Domestic Hot Water Heater & Storage Tank, 2023.

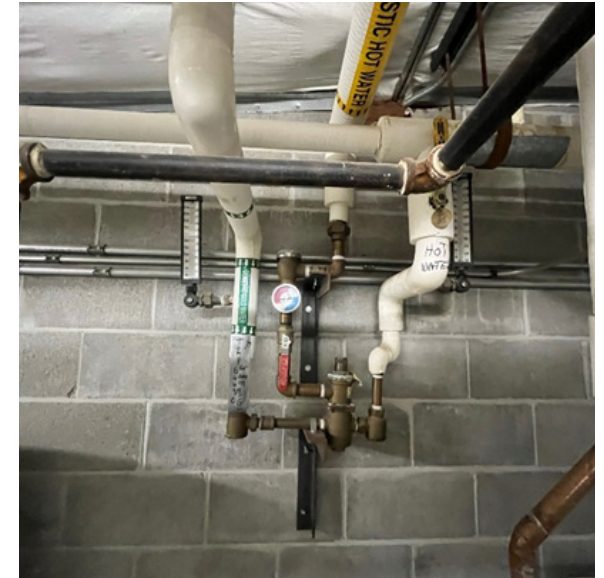
Fig. 3.5.13: 1994 Addition: Domestic Hot Water Mixing Valve, 2023.

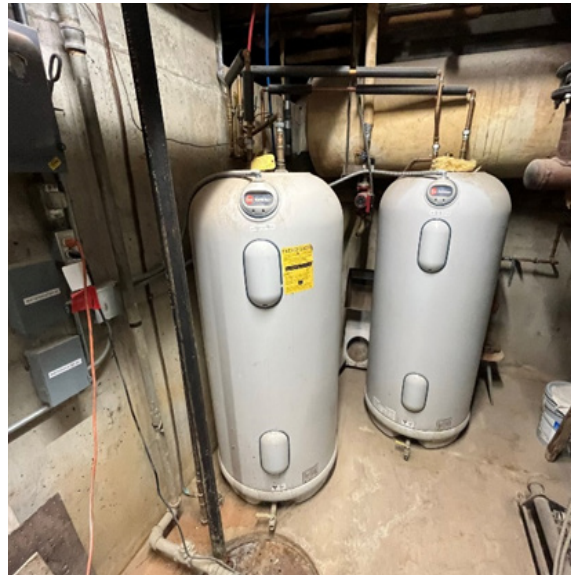
The building contains (2) separate domestic hot water heating systems. The first domestic hot water system is located in the lower-level boiler room and serves the original 1961 building. This system consists of (2) 100 gallon electric water heaters which replaced gas water heater in 2005. The electric water heaters store and deliver water at 110°F and does not contain a

Fig. 3.5.14: 1961 Original Building: Domestic Hot Water Heaters, 2023.

The domestic hot water heating system in the basement of the 1961 building should be changed to storage hot water at 140°F and install a mixing valve to deliver hot water at 110°F to reduce the change of bacteria growth (*Legionella Pneumophila*) within the system.

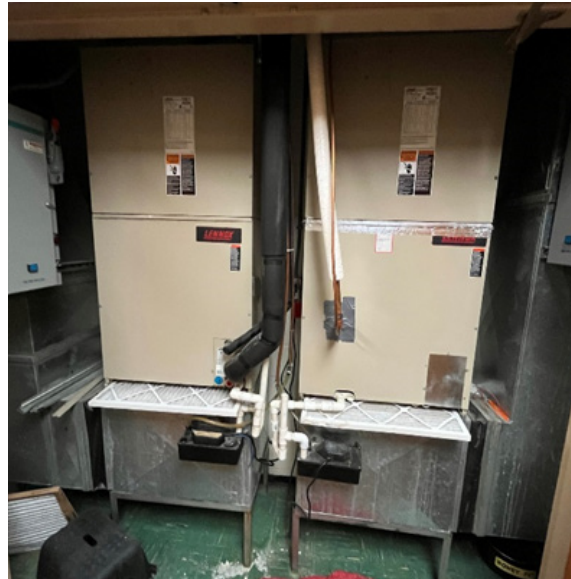
Fig. 3.5.16: Typical Split System Indoor Units, 2023.

Many of the split system heat pumps are 10 years old. Split system units have a life expectancy of 15 years. The school should start budgeting for replacement of these unit in approximately 5 years.

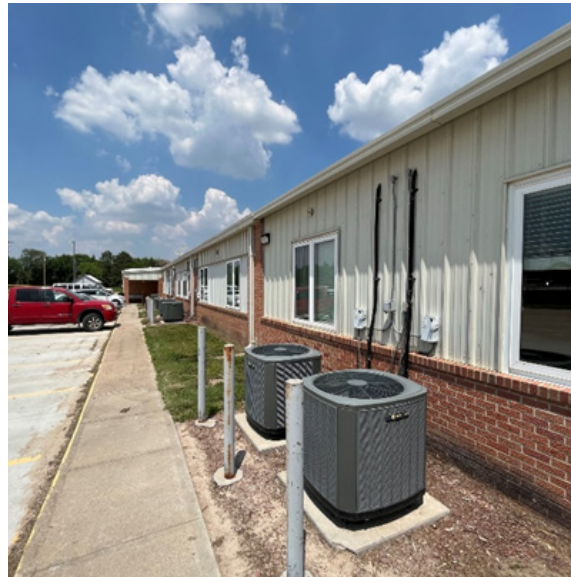
Fig. 3.5.18: Typical Split System Outdoor Air Source Heat Pumps, 2023.

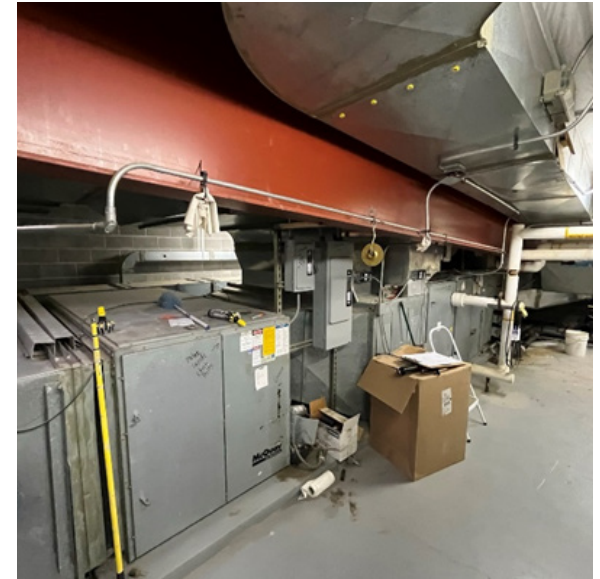
In 1994 a (locker room, multi-purpose, FCS, and kitchen) addition was added to the west side of the building. An upper mechanical mezzanine ovetop of the locker rooms was created for a multi-zone air handling unit and hydronic heating water system. The air handling unit contains (8) zones and delivers heating and cooling to the addition. The air handling unit was also designed to extend and serve the original locker rooms located below the gymnasium stage. The DX coil and condensing unit was replaced in approximately 2015.

Fig. 3.5.17: 1994 Addition: Multi-Zone Air Handling Unit, 2023.

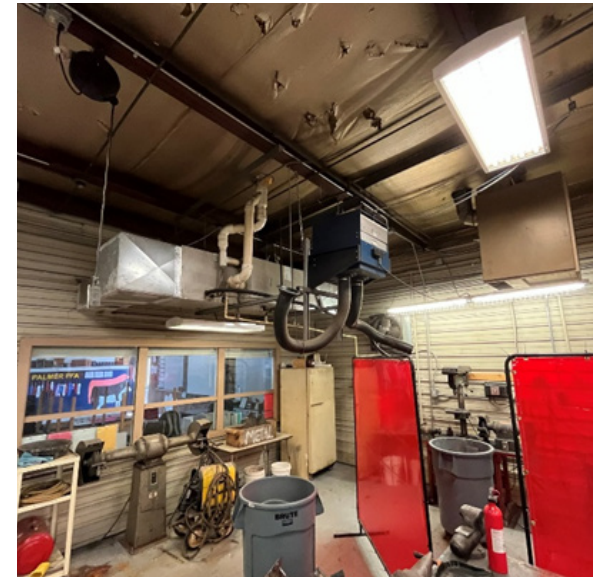
The shop is heated by (2) gas fired unit heaters. The shop is not air conditioned. The unit heater in the southeast corner appears to be original to the shop and the northeast unit heater appears to be new. The Ag classroom is served by a gas fired split system furnace and air conditioning unit. The split system appears to be original to the shop.

Fig. 3.5.19: Shop: Ag Classroom Split System A/C & Shop Unit Heater, 2023.

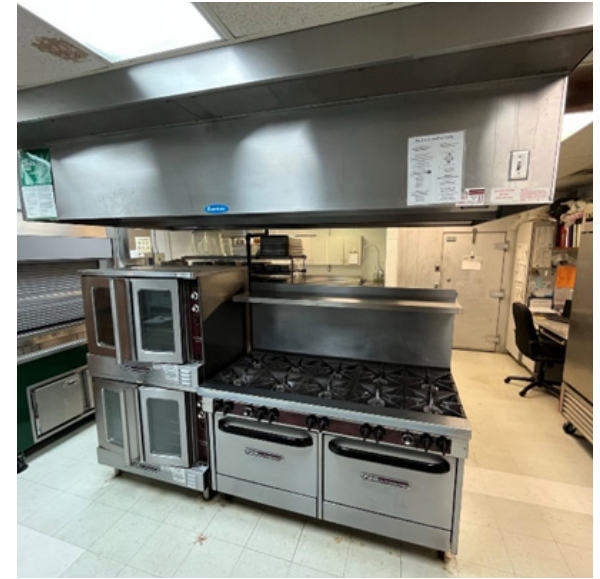
The kitchen contains a type 2 condensate hood overtop of the dishwasher and a type 1 island grease hood overtop of the cooking appliances. Makeup air is introduced into the space via the short circuit kitchen hood from a dedicated gas fired makeup air unit located on the roof. The type 1 grease hood is a fully welded hood and appears to meet current code and is in decent condition. The type 2 hood exhaust fan would not operate when the wall switch is turned on.

Fig. 3.5.20: Type 1 Kitchen Grease Hood, 2023.

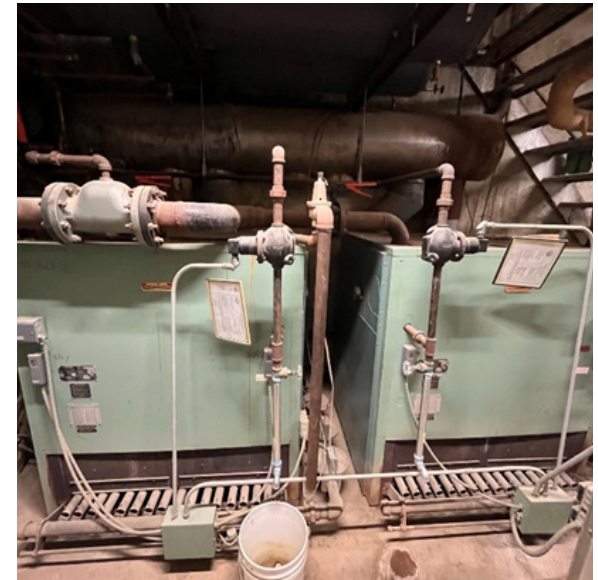
The boilers located in the basement of the original 1961 building are (2) Peerless atmospheric, cast iron, gas-fired hot water boilers. These boilers supply perimeter fin tube heating and corridor console wall mounted unit heaters throughout the 1961 building as well as the unit heaters in the gymnasium. The boilers were installed in 1985 (38 years old) and have meant their useful life span. The hydronic piping in the 1961 building is steel piping and original to the building. The hydronic zone pumps in the basement boiler room appear to be newer and in decent condition.

Fig. 3.5.21: 1961 Original Building: Hydronic Hot Water Boilers, 2023.

The boilers in the 1961 original building are nearing 40 years old and beyond their life expectancy. Consider replacement of these boilers in the near future.

A further evaluation of the existing hydronic piping and insulation should be performed to determine the condition of the piping in the 1961 original building.

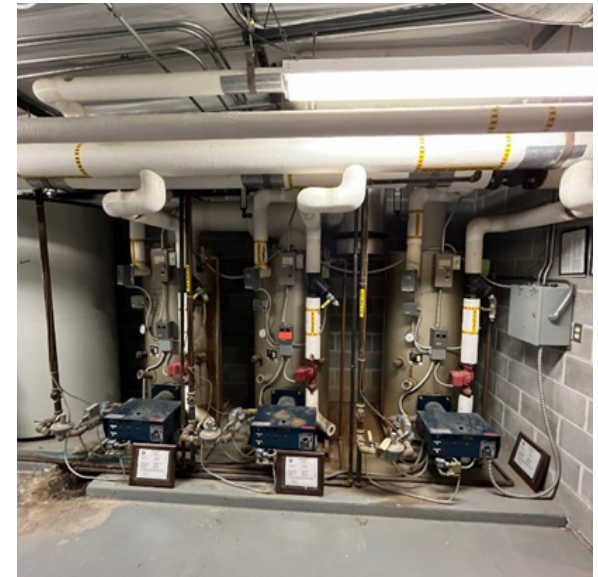
The 1994 addition contains (3) LES V-78 gas fired, vertical fire tube boilers that serve the multi-zone air handling unit and serve multiple backup heating hot water coils to the air source heat pump split system unit in the south classrooms. These boilers are original to the 1994 addition (29 years old) and appear to operate in decent condition. The piping and insulation appear to be good condition.

Fig. 3.5.22: 1994 Addition: Hydronic Hot Water Boilers, 2023.

The boilers in the 1994 addition are nearing 30 years and coming up on their life expectancy. The school should consider budgeting for the replacement of these boilers.

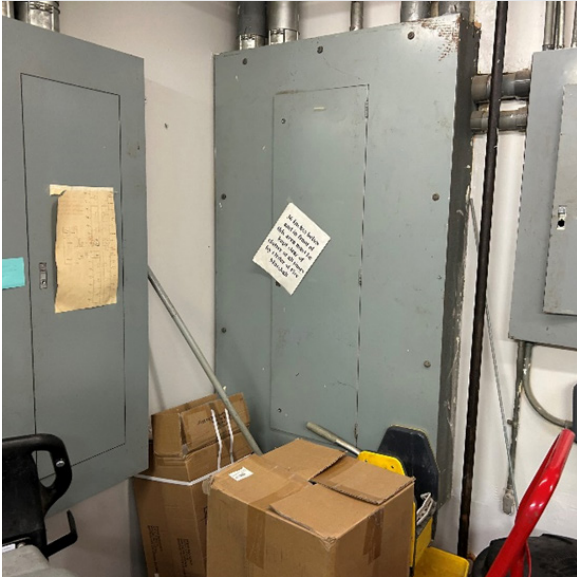
There is no surge protection device on the service equipment. No visible main ground bar was observed.

Fig. 3.6.4: Main Panelboard and Branch Panelboards, 2023.

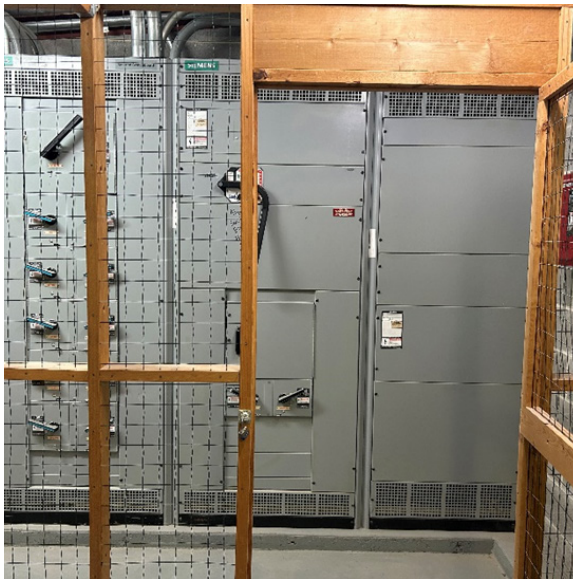
Fig. 3.6.6: Main Switchboard, 2023.

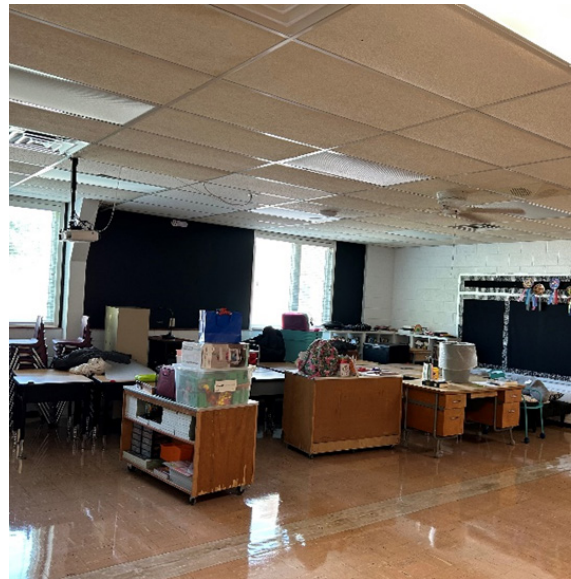
Lighting throughout the building comprises mostly of fluorescent lamp fixtures, some LED fixtures were observed. Classrooms and corridors have 2x4 lensed troffers. The multipurpose room has surface mounted wraparound fixtures. Mechanical, Electrical, Storage, and other similar areas have strip lights. The Kitchen has enclosed, gasketed, watertight fixtures.

Fig. 3.6.7: Typical Classroom, 2023.

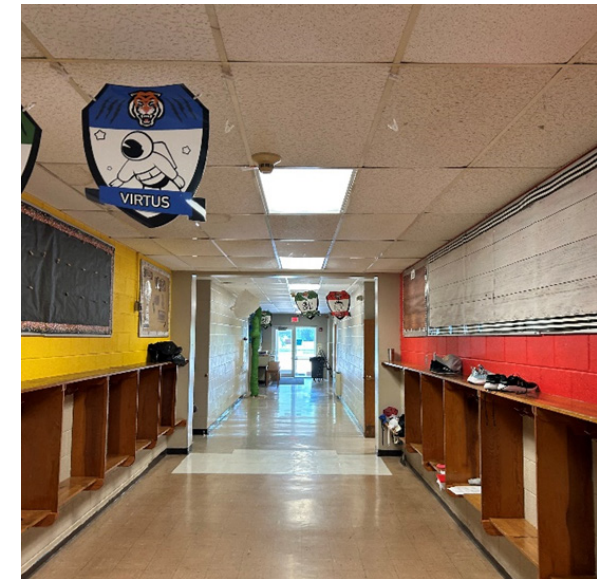
Fig. 3.6.8: Typical Corridor, 2023.
